Manhole Inspection Summary

Manhole # S33MM_001MH

Insp Date: **3/15/07 9:25 AM**

Location Address: **2001 CHARLES ST**

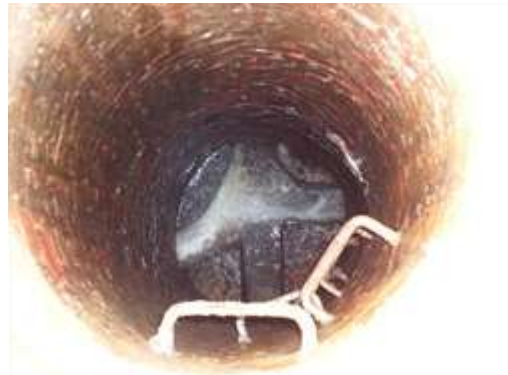
Top View

Adjustment and Barrel infiltration.
Corroded steps. Bench debris.

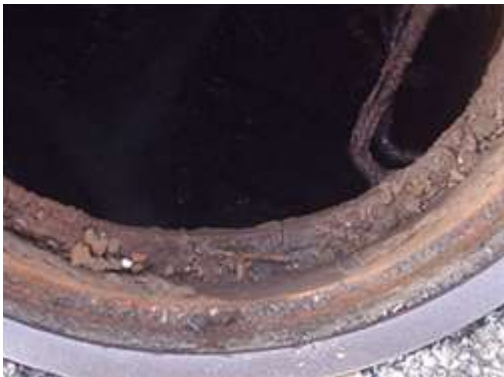
Defect

Frame leaks. Frame offset.

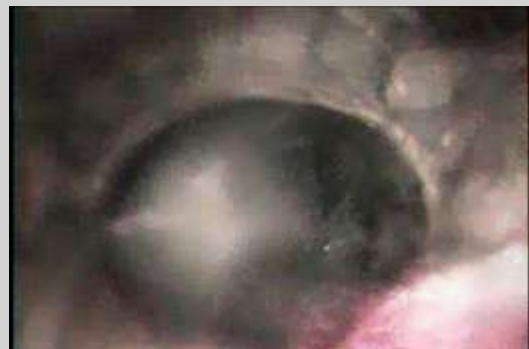
Drop In @ 3 O'Clock

Drop Condition: **Clogged**

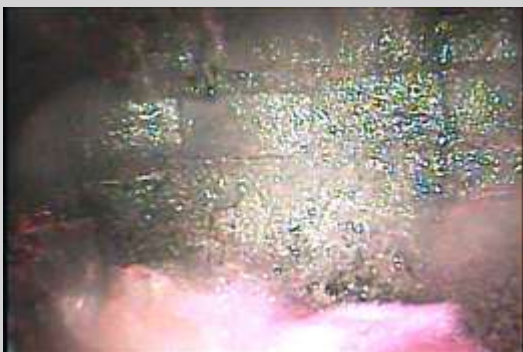
Pipe In @ 9 O'Clock

Connects To: **Stub connection / abandoned**
